6.12.5 The Four Cases

6.12.6 Characterization of the Thermal Profiles

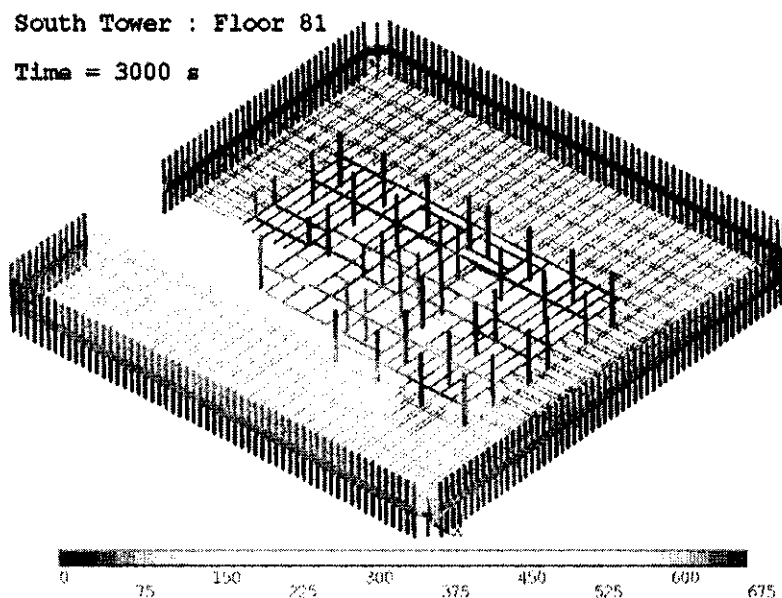
For ease of visualization, two graphic representations were developed. Figure 6–46 shows an example of the temperature map for the 96th floor of WTC 1. Severed columns and broken floor segments are not shown. Figure 6–47 shows a similar map for the 81st floor of WTC 2.

Figure 6–47. Temperatures (°C) on the columns and trusses of the 81st floor of WTC 2 at 3,000 s after aircraft impact, Case D.

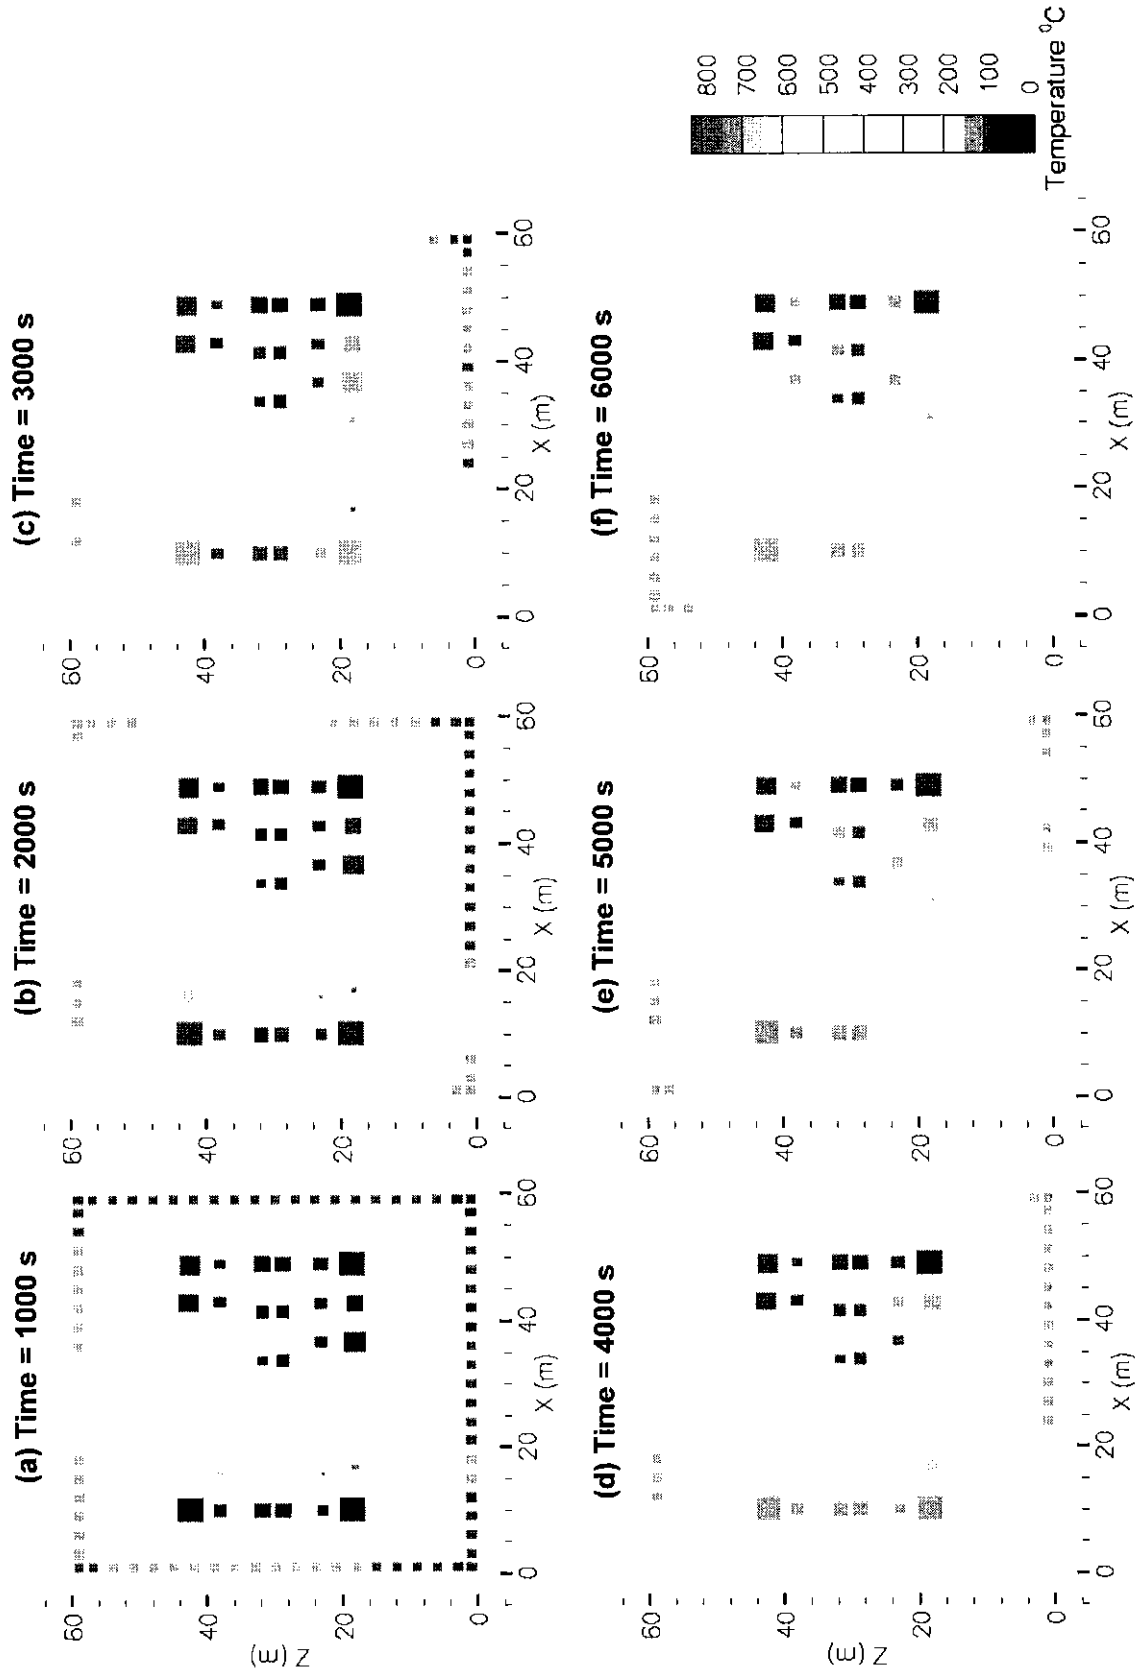
A third visualization tool was animation of the evolving temperatures of the columns. Frames from an example, again of the 96th floor of WTC 1, Case A, are shown in Figure 6–48. The size of the square representing a column represents its yield strength. Columns may have been heated when the fire was nearby and then cooled after the local combustibles were consumed.

Figure 6-48. Frames from animation of the thermal response of columns on the 96th floor of WTC 1, Case A.
